National Dam Inspection Program  
UNIVERSITY OF MARYLAND  
BALTIMORE COUNTY

DAM (NDI-ID Number MD34)

PHASE I INSPECTION REPORT

AUGUST 1980

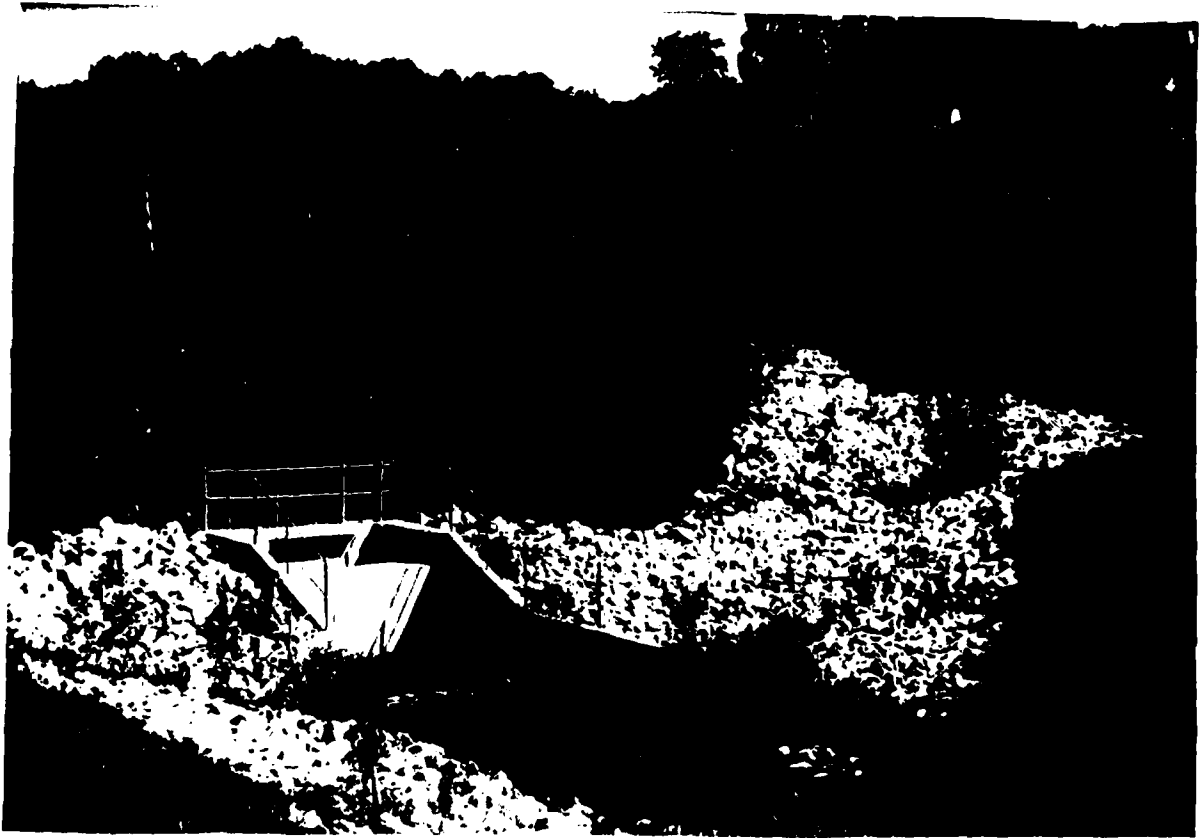
Overview of Dam

Based on the evaluation of available design information and visual observations of conditions as they existed on the dates of the field reconnaissances, the general condition of UMBC Dam is considered to be good. However, the accumulated debris and sediment obstructing the principal spillway entrance structure is considered to represent a potential hazard to the dam. Immediate removal of the debris and sediment and construction of an improved trash rack(s) or cage is advised. The presence of surface erosion on the embankment-spillway abutment and around the impact stilling basin, and tree and woody shrub growth located along the embankment-spillway abutment, downstream slope and exit channel, are considered minor deficiencies in need of maintenance.

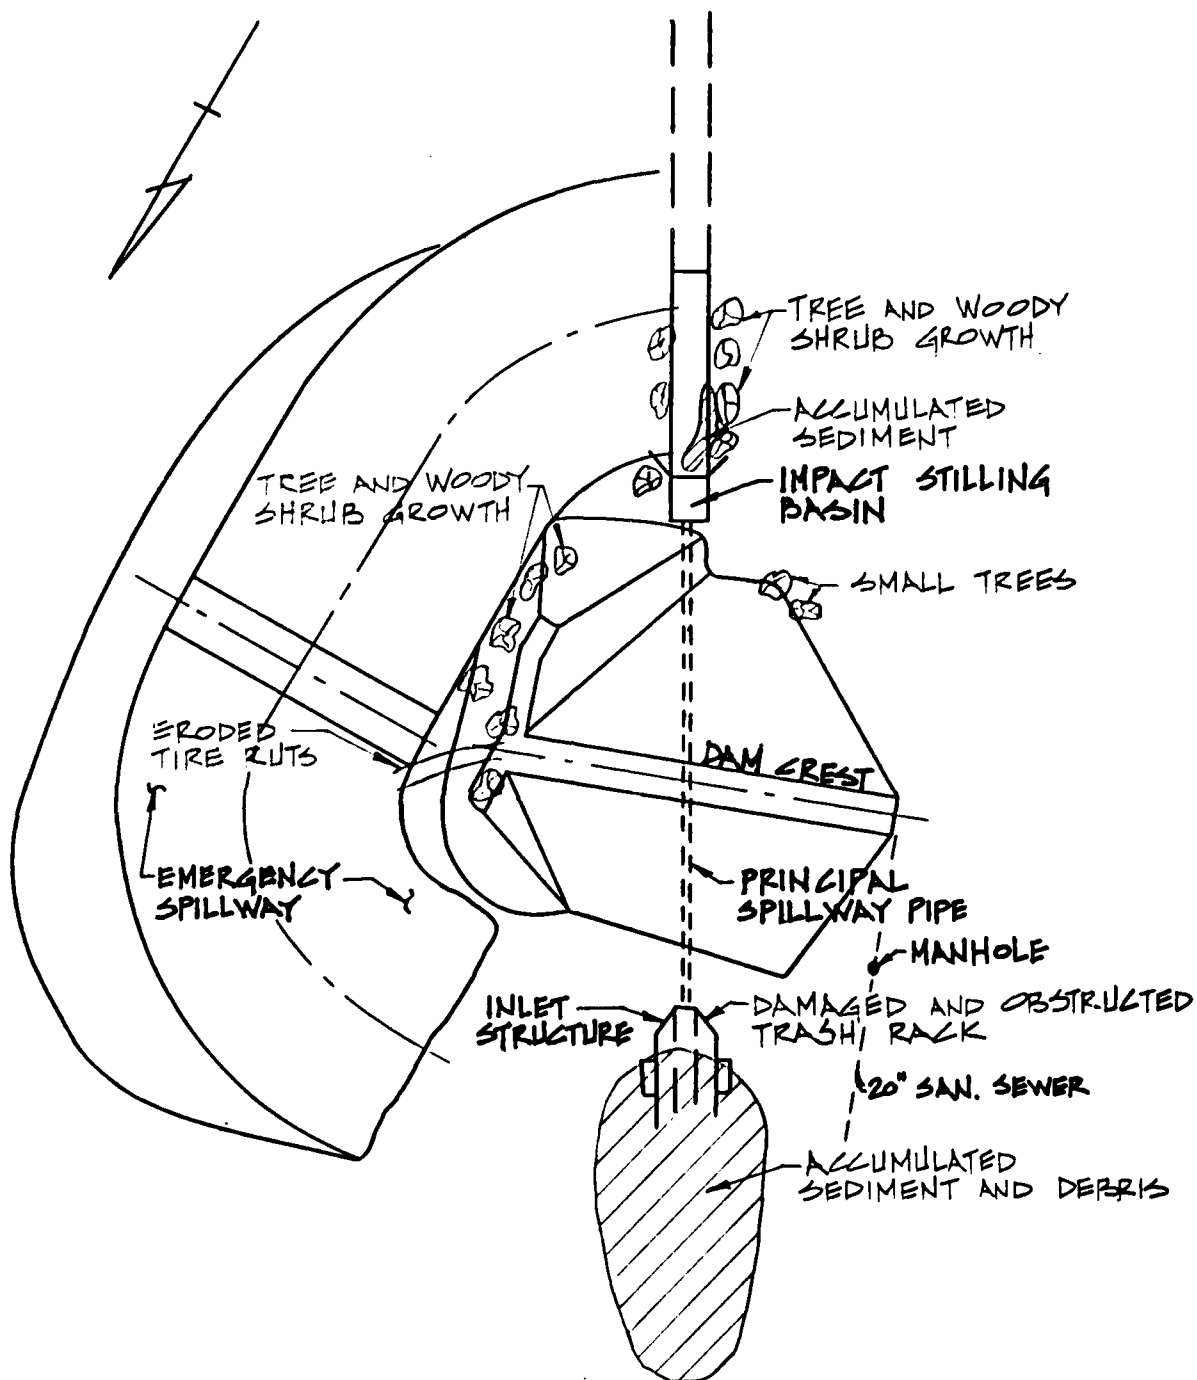
DATE: AUG. 8, 1980	NATIONAL DAM INSPECTION PROGRAM		U. M. B. C. DAM FIELD SKETCH
SCALE: NONE			
DR: JLM CK: TED	ACKENHEIL & ASSOCIATES CONSULTING ENGINEERS BALTIMORE, MD.		
DWG. NO. A-10

- B. EMBANKMENT: Embankment slopes had field measured inclinations approximating 3H:1V and a crest width of 20 ft. Embankment crest and slopes had a dense grass covering and appeared stable. Trees and woody shrubs were located along the embankment-spillway abutment, extending from dam centerline to the impact stilling basin. Eroded tire ruts were observed along the dam crest, bottom of the spillway channel, and embankment-spillway abutment (see field sketch).
